CITY OF MUNCIE, INDIANA

# American with Disabilities Act Transition and Implementation Plan

December 2, 2011

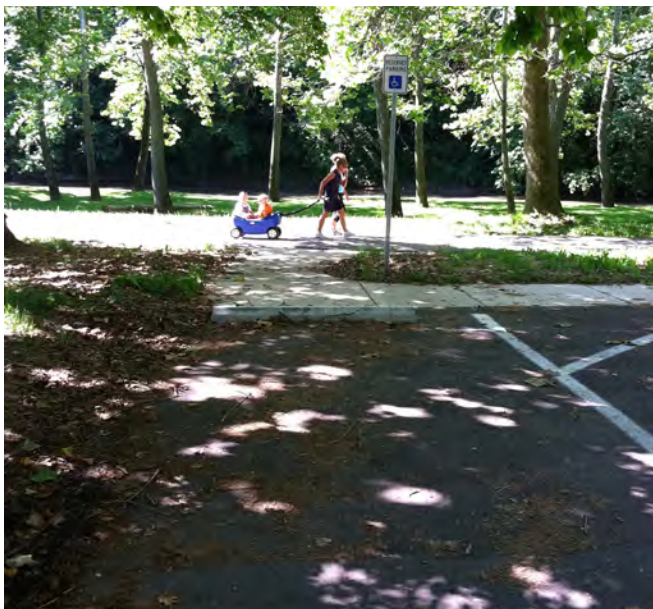
Accessible parking at trailhead

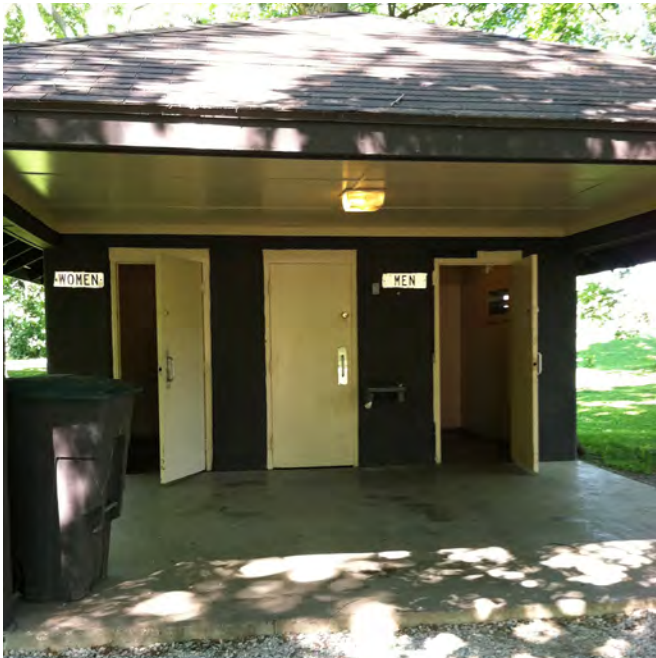
Restroom building with attached drinking fountain

| COMPLIANCE ITEM AND CORRECTIVE ACTION | PRIORITY | ESTIMATED COST |
|---|---|---|
| Provide accessible route from Playground ADA parking stall to the restroom. Replace gravel path from park road to restroom building with paved walk. | High | \$5.00 LF (5' wide, asphalt) |

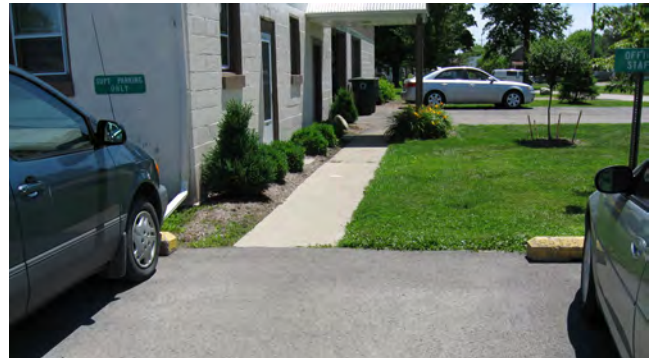
Proposed location of accessible parking at park office.

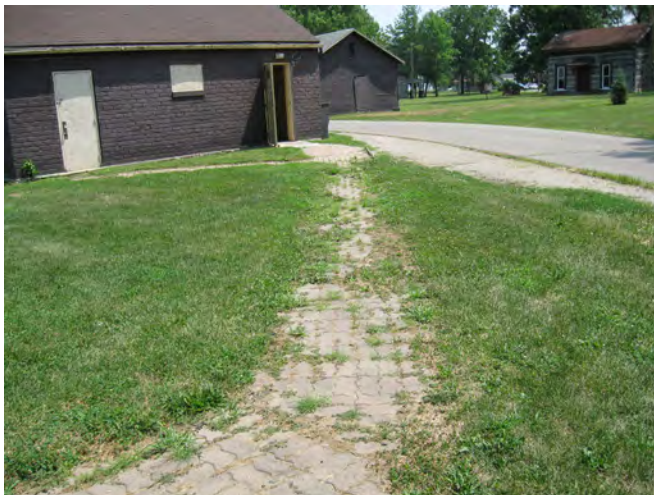
Approach to Men's Restroom Door

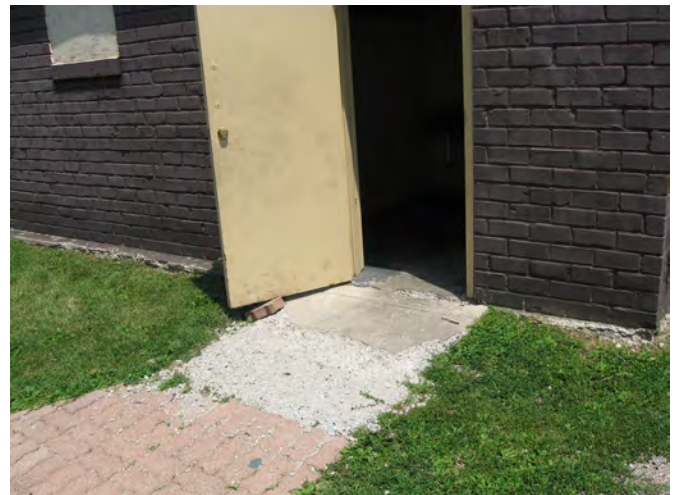
Concrete Pad at Men's Restroom Door

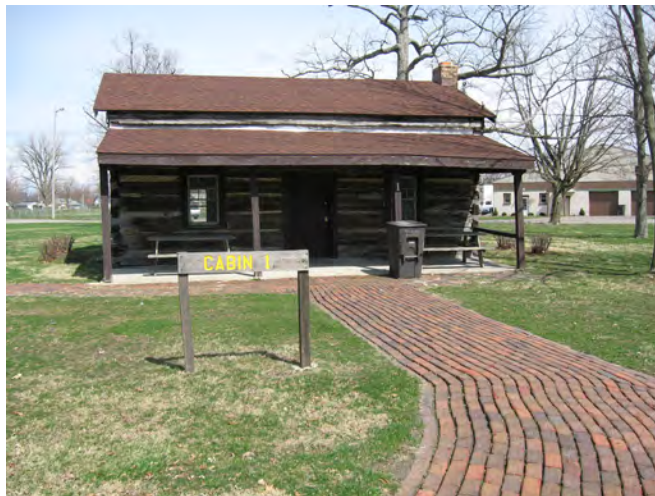
Cabin 1 Approach

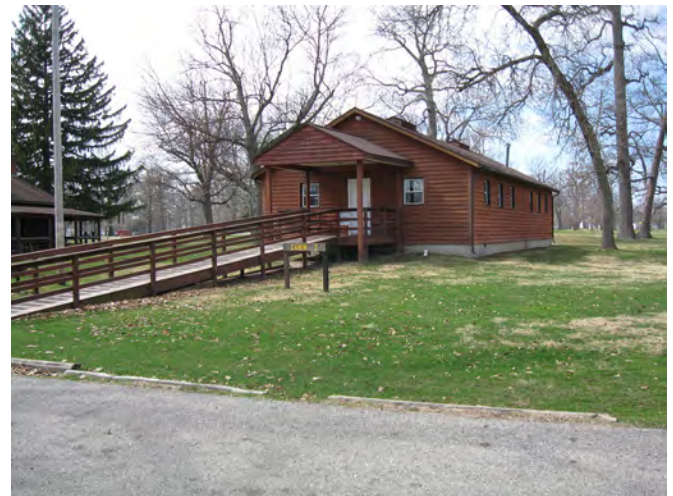
Cabin 3 Approach

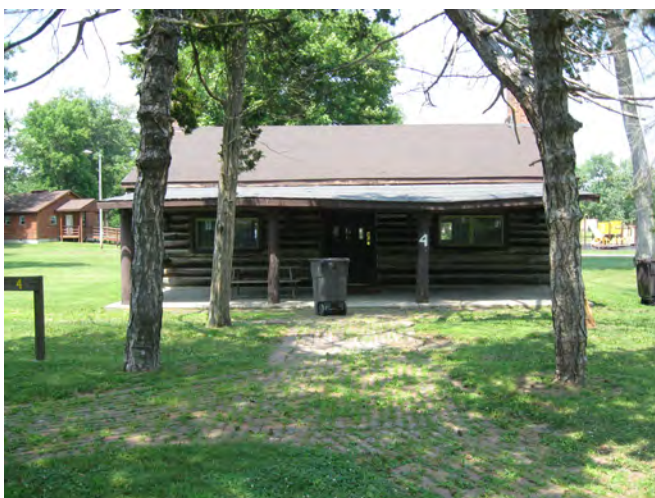
Cabin 4 Approach

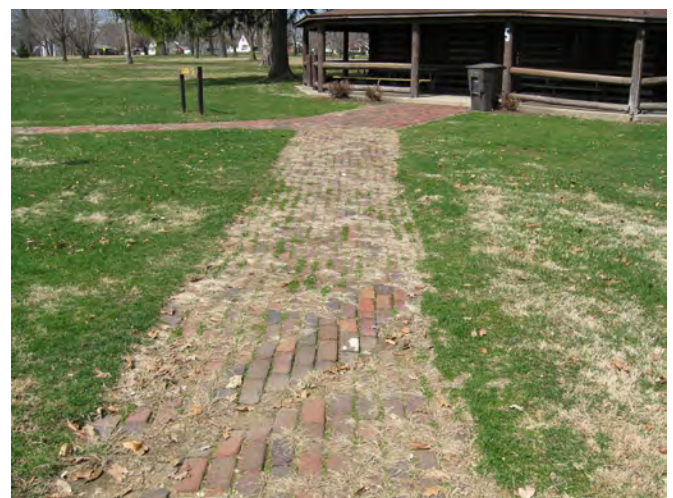
Cabin 5 Approach

| COMPLIANCE ITEM AND CORRECTIVE ACTION | PRIORITY | ESTIMATED COST |
|---|---|---|
| Repair or replace walk to Cabin 5 | High | \$2.50 SF (asphalt)<br>\$4.00 SF (concrete) |
