CITY OF MUNCIE, INDIANA

# American with Disabilities Act Transition and Implementation Plan

December 2, 2011

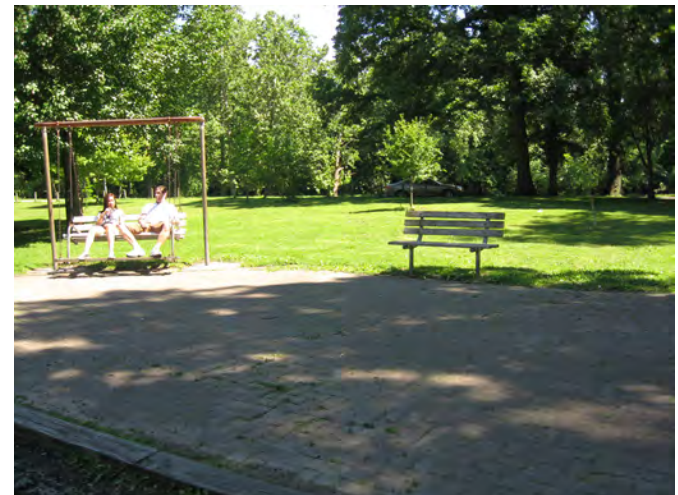
Seating and swing at playground

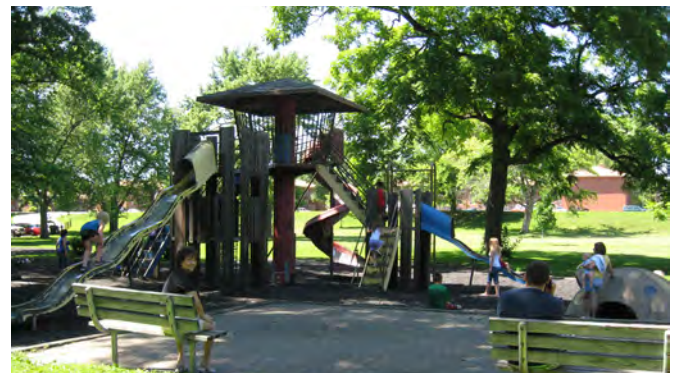
Playground structure

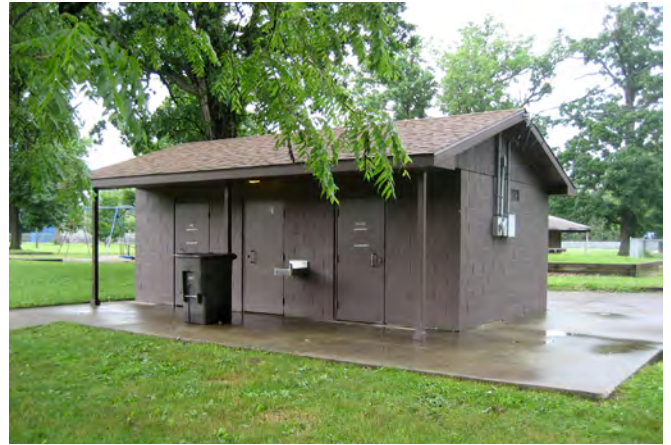
- drinking fountain- noncompliant and inoperative, is not cane-detectable
- signage- noncompliant

| RESTROOMS GENERAL CORRECTIVE ACTIONS | ESTIMATED COST | PRIORITY |
|---|---|---|
| Install ADA compliant signage on both restrooms | \$60.00 | High |

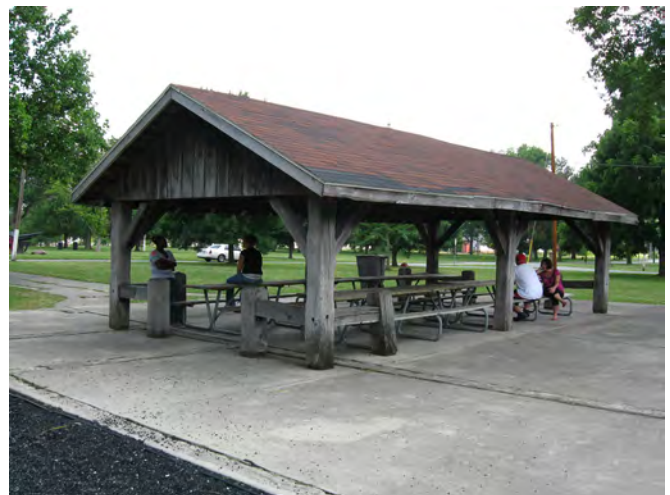
Heekin Park picnic shelter.

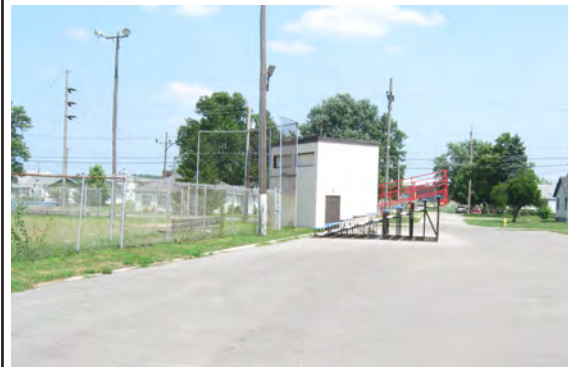
- The baseball diamond is not currently used for scheduled play, but may be used for informal pick-up games or practice. Because the field sees little play, improvements for this amenity are a low priority.
- Parking is provided adjacent to the ball diamond, in the unmarked parking lot that serves the park office.
- Bleachers for the ball diamond sit on the asphalt parking lot pavement. A person using a wheelchair could sit alongside the bleachers to watch a game.
- The diamond itself does not include an accessible route to the bench/field.

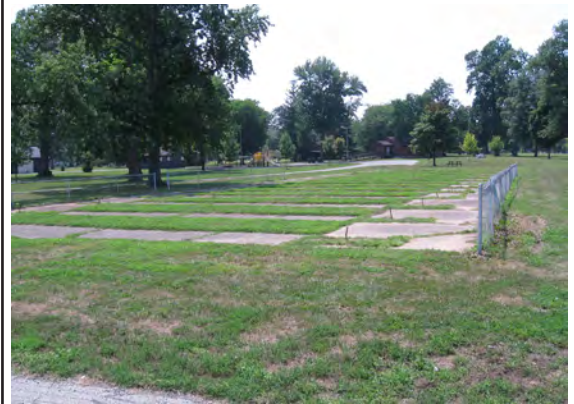
- The eight horseshoe pits are in poor condition and see little play. Consequently, the ADA improvements to this amenity are medium to low priority.
- While ADA standards/guidelines specifically for Horseshoe pits have not been developed, improvements based upon current standards and practices can provide greater accessibility to this amenity. These improvements include
  - accessible parking
  - an access route to the amenity
  - clear turning spaces and an access route to allow travel from one end of the pit to the other
- Given the limited amount of use of this amenity, it is recommended that initial improvements are made to provide access to a minimum of one horseshoe pit.

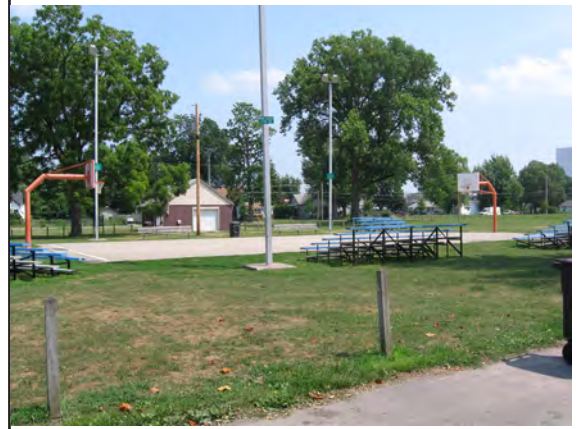
A single basketball court with associated bleachers is located in the northeast corner of the park.

- Parking is provided at an adjacent parking lot.
- An access route from the parking lot to the court and the bleachers is needed.
- A paved pad adjacent to the bleachers would provide opportunities for a person using a wheelchair to watch a game and interact with others on the bleachers.

| COMPLIANCE ITEM AND CORRECTIVE ACTION | PRIORITY | ESTIMATED COST |
|---|---|---|
| Add access route from parking lot to bleachers and basket ball court. | High | \$5.00 LF (5' wide, asphalt) |

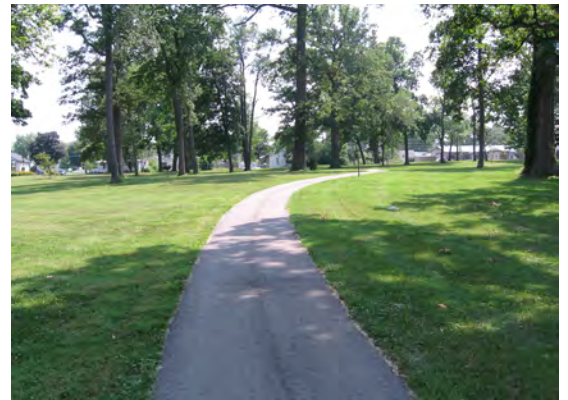
An asphalt walking trail meanders through the wooded area of the park located adjacent to 12th Street. The trail is a circular path that is accessed from the park road.

- Unmarked parking is available along the road or marked parking at the playground parking lot.
- The majority of the trail is within ADA standards for slope, with the exception of the approach immediately adjacent to the road. The approach could be modified to accommodate the existing grade change with a longer, more moderately sloped connection to the road.

| COMPLIANCE ITEM AND CORRECTIVE ACTION | PRIORITY | ESTIMATED COST |
|---|---|---|
| Add accessible parking adjacent to trail access. | Low | \$2.50 SF (asphalt)<br>\$200.00 signage and striping |

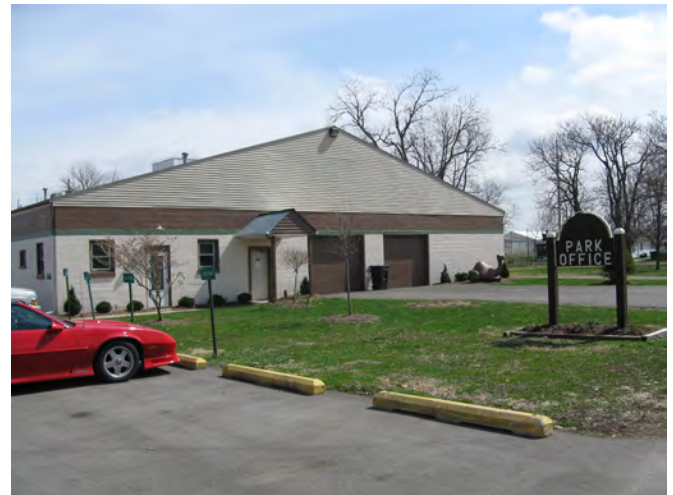
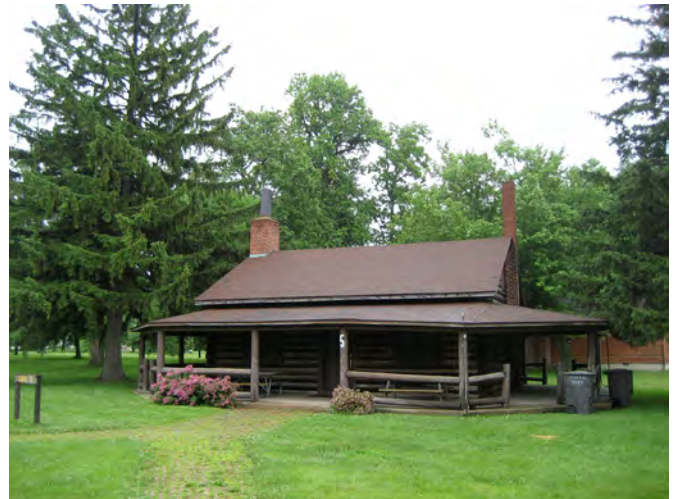
Compliance with the Standards is only required of new construction and remodel work. The existing cabins could be left as-is, but bringing as many of them into compliance as practical would be a benefit to the citizens of Muncie. This puts the cabins into three categories:

- Low-hanging fruit: Cabins 1, 4, and 5 can be brought into compliance with little effort.
- Costly but critical: Cabin 3 requires a fair amount of remodeling. The toilet room is an extra amenity not provided in the other cabins, and will require moving walls to bring into compliance. The existing ramp is "close to compliant" and should be replaced, but is a much lower priority than the toilet room.
- Not recommended: Cabin 2 can't be brought into complete compliance without serious structural implications to the historic nature of the building. In these cases, some modifications can be made to make the building easier to access. They are given a lower priority, as available funds should first be spent on other recommendations.
